Maintainer

Issue 4/2004

Static Electricity: An Ever-Present Danger!

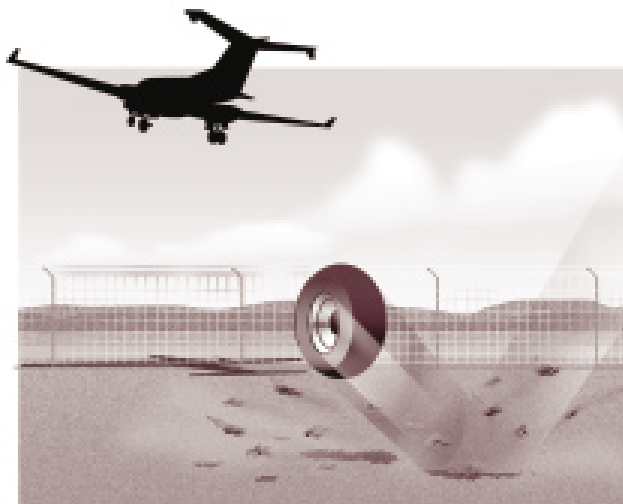
The flight of a Beech 1900D did not get off to a successful start; shortly after becoming airborne, the tower controller advised the pilot that a wheel assembly had been seen falling from the aircraft. The crew immediately returned to the airport and made an uneventful landing. The failed No. 3 position wheel assembly had approximately 400 hr in service. It was recovered and inspected in order to establish the cause of failure. It had been serviced 425 hr earlier, as the maintenance had coincided with a tire replacement schedule. This interval met the manufacturer's recommendation, and although there had been no other servicing requirements for this type of wheel assembly, it seems to have led to several similar occurrences in the past.

Following this last incident, the operator initiated an evaluation program to help identify the cause. Every one in maintenance participated and several issues came to light as possible elements leading to the premature failure of the bearings. For instance, a new landing gear cleaning process was adopted. It took into account the compatibility of the cleaning agents and the resistance of the wheel assembly seals and bearing lubricants to high pressure washing techniques. A new synthetic wheel bearing lubricant was chosen because of its resistance to load, high temperature and various chemical agents present in corrosive environments. The serviceability of aircraft wheel assemblies is influenced by the quality of the maintenance carried out; the type of lubricant used; the environmental conditions to which they are subjected, such as corrosive air and gases, dust, and water; the frequency of the use of chemical solvents for cleaning; and the normal wear and tear from take-off and landing cycles.

Not all lubricants are created equal; some will give improved life to bearings under very specific conditions and others will not. Operators who experience serviceability problems should review their aircraft maintenance evaluation program to ensure that it meets current operational conditions. *Canadian Aviation Regulations (CARs) Standard 726.07* was initiated to ensure that operators would have a system, irrespective of the type of operations, to adequately control all airworthiness matters that could affect the operation of aircraft. It states that, "the program should provide an unbiased picture of the Air Operator's performance, to verify that activities comply with the MCM [maintenance control manual] and confirm that the systems and procedures described in the MCM remain effective and are achieving the Air Operator's requirements." The aircraft maintenance evaluation program serves to review reported maintenance occurrences and to determine, in a timely
